3/4" Cross-slide leadscrew replacement

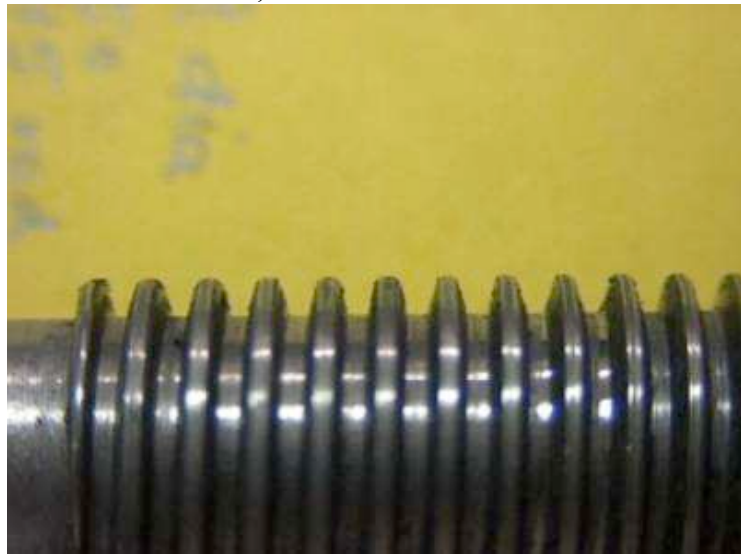
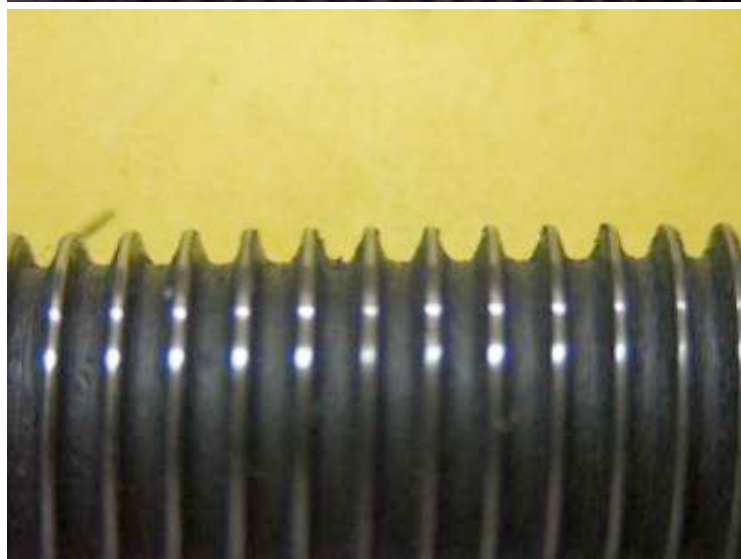
While restoring my Clausing 8520 mill, I decided I wanted to reduce the backlash in the cross-feed. I hadn't even pulled anything apart yet, but I knew the cross-feed handle spun one whole turn before the table moved, so that's .100" backlash. I pulled everything apart, and could see the actual wear on the leadscrew and nut. The acme threads on the ends were still robust, but the threads in the middle were so worn they looked like regular, 60 degree threads.

I called Clausing, and they had the parts available, but it would cost close to \$500. The bulk of this article will deal with how I replaced the leadscrew and nut using off-the-shelf parts from McMaster-Carr and a little effort for < \$150.

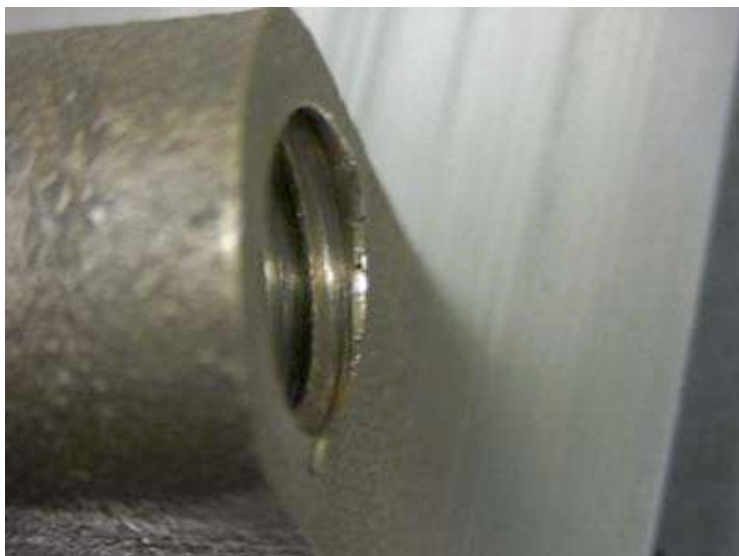
Also, the bronze table nut exhibited the same problem

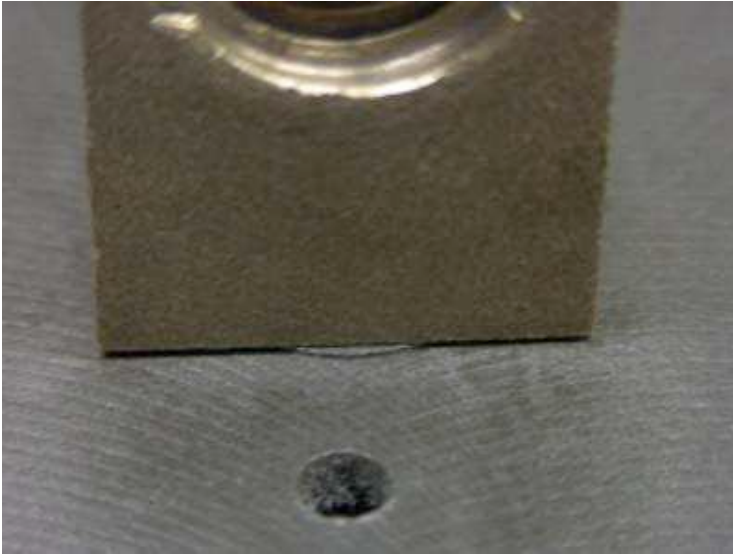
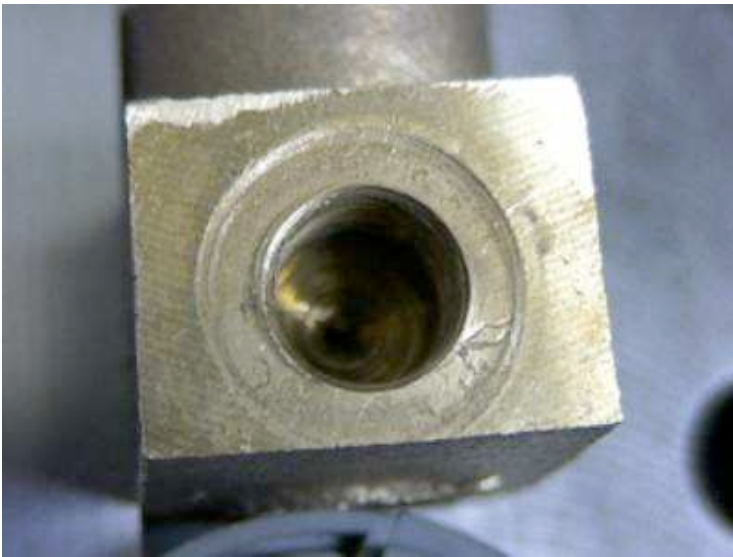
My main concern was whether there would be enough material to mill a sufficient-sized flat to mount the nut without some hokey shimming strategy. The original part 'floats' on a couple of precision washers, which had imprinted themselves in the bottom of the bronze nut over 40 years which made measuring a challenge.

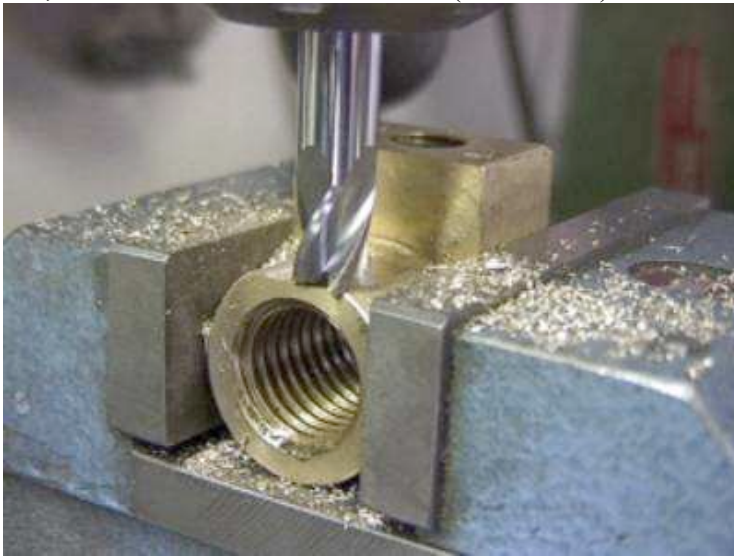
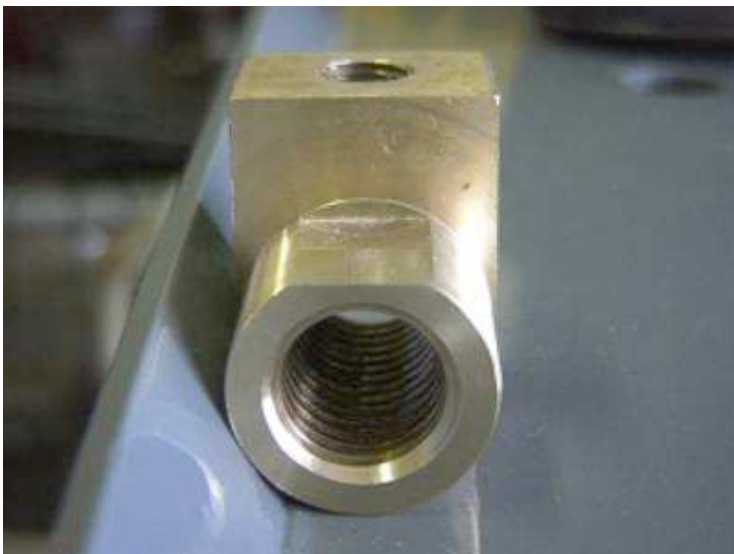
However, I was to learn later that I had one more machining operation before I was finished. Due to the increased diameter of the screw, the 'nose' interfered with the knee when extended furthest away from the column. To rectify this, I relieved some metal off the nut (about .065").
