3/4" Cross-slide leadscrew replacement

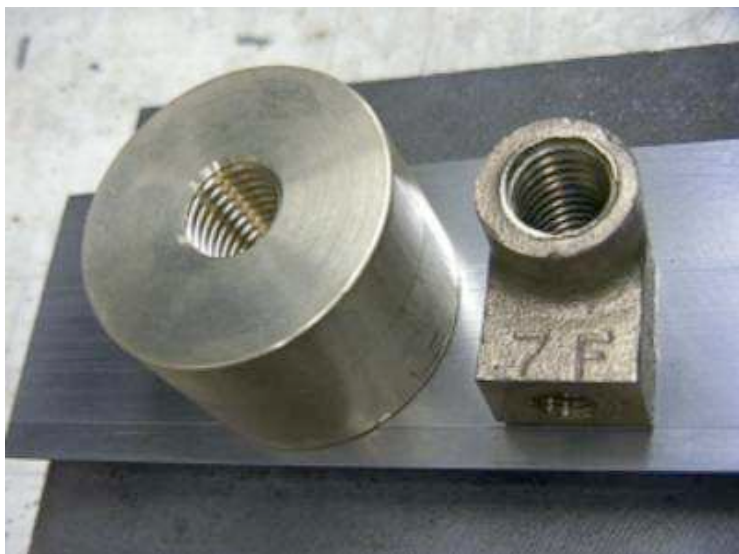
I started with the table nut, because I thought it was the more challenging component. Here's a look at the old nut next to the machinable nut.

My main concern was whether there would be enough material to mill a sufficient-sized flat to mount the nut without some hokey shimming strategy. The original part 'floats' on a couple of precision washers, which had imprinted themselves in the bottom of the bronze nut over 40 years which made measuring a challenge.

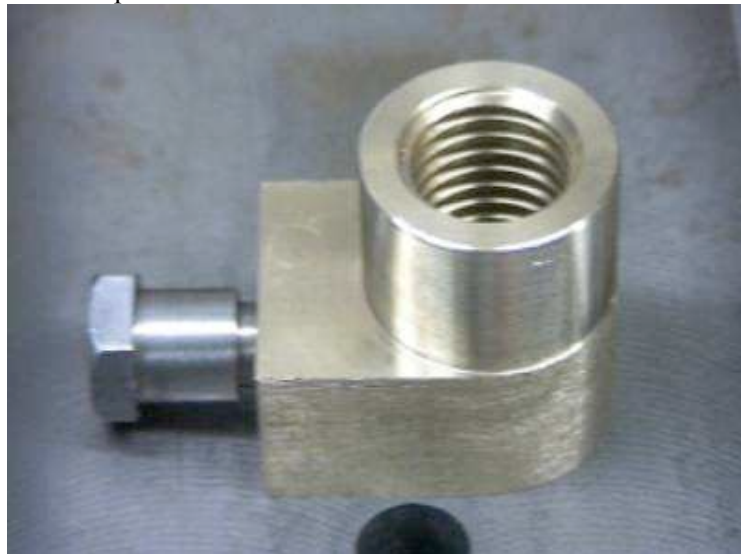
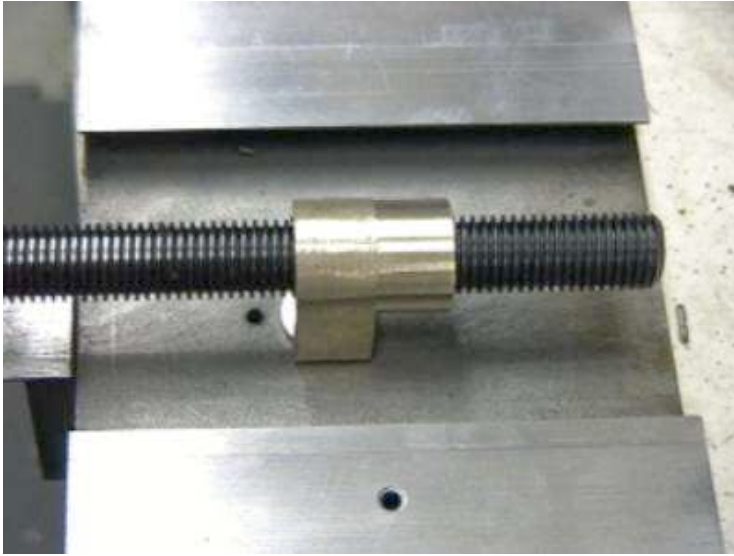
Here's a picture of the finished nut and mounted to the saddle.

However, I was to learn later that I had one more machining operation before I was finished. Due to the increased diameter of the screw, the 'nose' interfered with the knee when extended furthest away from the column. To rectify this, I relieved some metal off the nut (about .065").

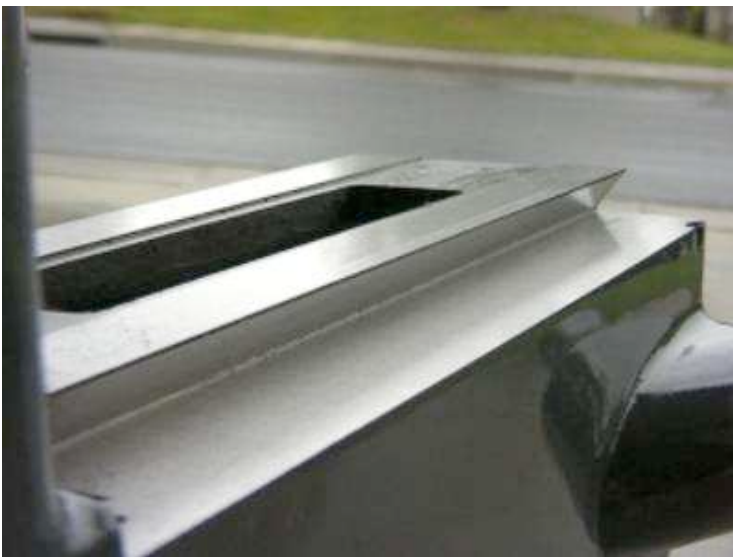
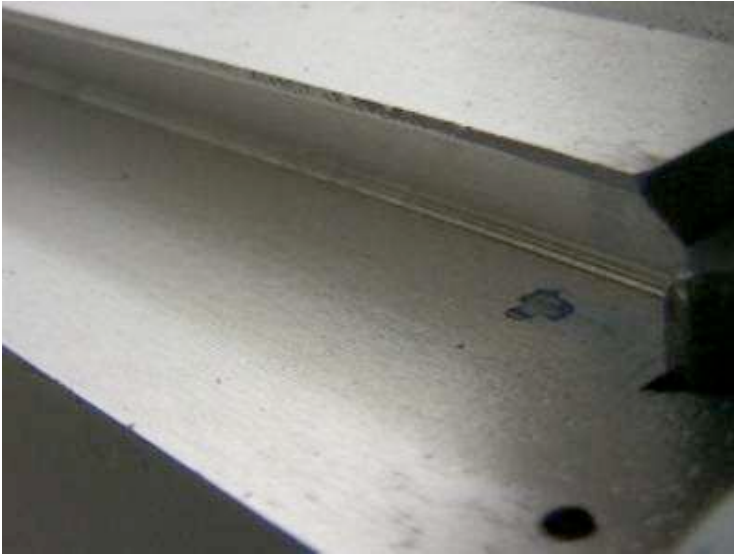
Lesson learned! I finished the above, but that only half-solved the problem. If the screw was that worn, it made sense that the ways would be horribly worn, too. Thus, I only had about 2.5" of travel in the middle, but the gib tightened up on either end. If loosened the gib, then the table rattled and shook in the middle. The only solution was a trip to Schaffer Grinding in Montebello. I brought them the knee, and they reground the top table ways. Made a world of difference. Now, it's smooth and tight the whole length of travel.
